## **Assessment of the Current State of Construction Materials of Some Historical Monuments in Georgia**

The study aims to assess the current condition of construction materials used in four significant historical monuments in Georgia - Sioni Cathedral (Tbilisi, VI-XI century), Anchiskhati Basilica (Tbilisi, VI century), Barakoni Church (Racha region, XVIII century), and Nikortsminda Cathedral (Racha region, XI century) - through mineralogical and physical-mechanical analyses. The methodology combines X-ray diffraction (XRD) analysis and standard physical-mechanical tests, and the results are compared with established reference values.

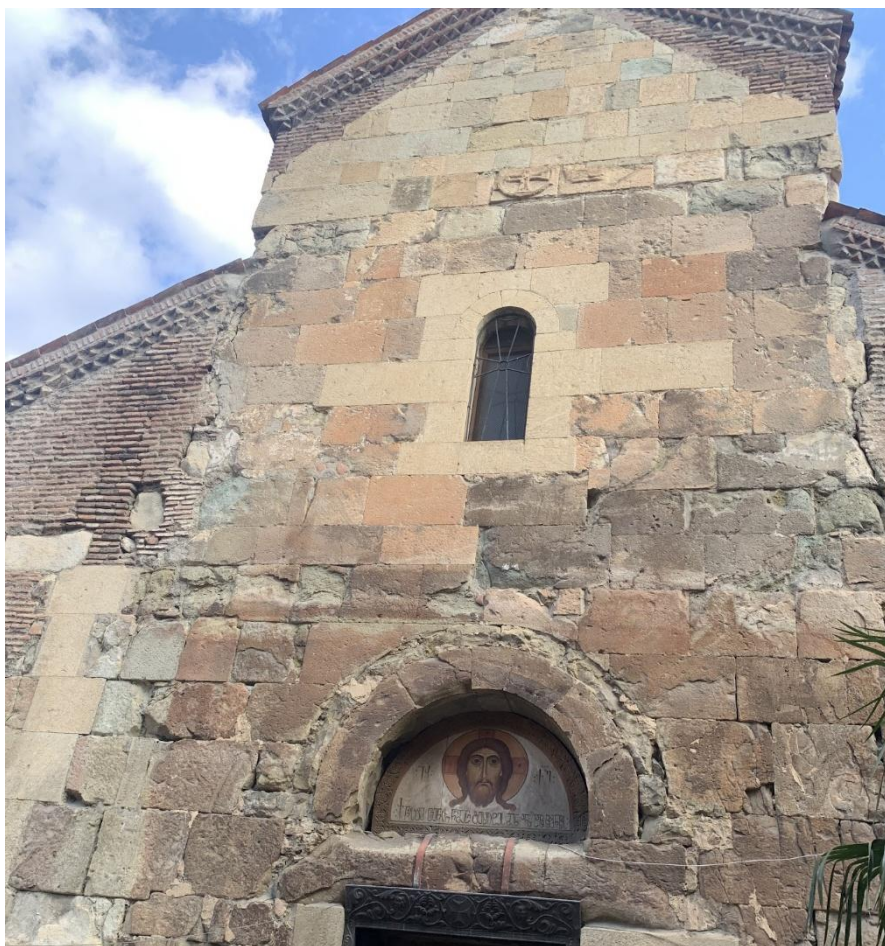
Anchiskhati Basilica (**Figure 1**), dating from the VI century, is a three-nave hall-type church located in the center of Tbilisi, near the Mtkvari (Kura) river. Originally built with squared blocks of yellow tuff, the upper parts of the walls and internal columns were reconstructed using brick during the XVII century. Its external and internal walls are faced with yellowish tuff tiles (Beridze, 2014).

**Figure 1.** Anchiskhati Basilica - main entrance.  
Note. Photograph by N. Dzebisashvili, 2025.

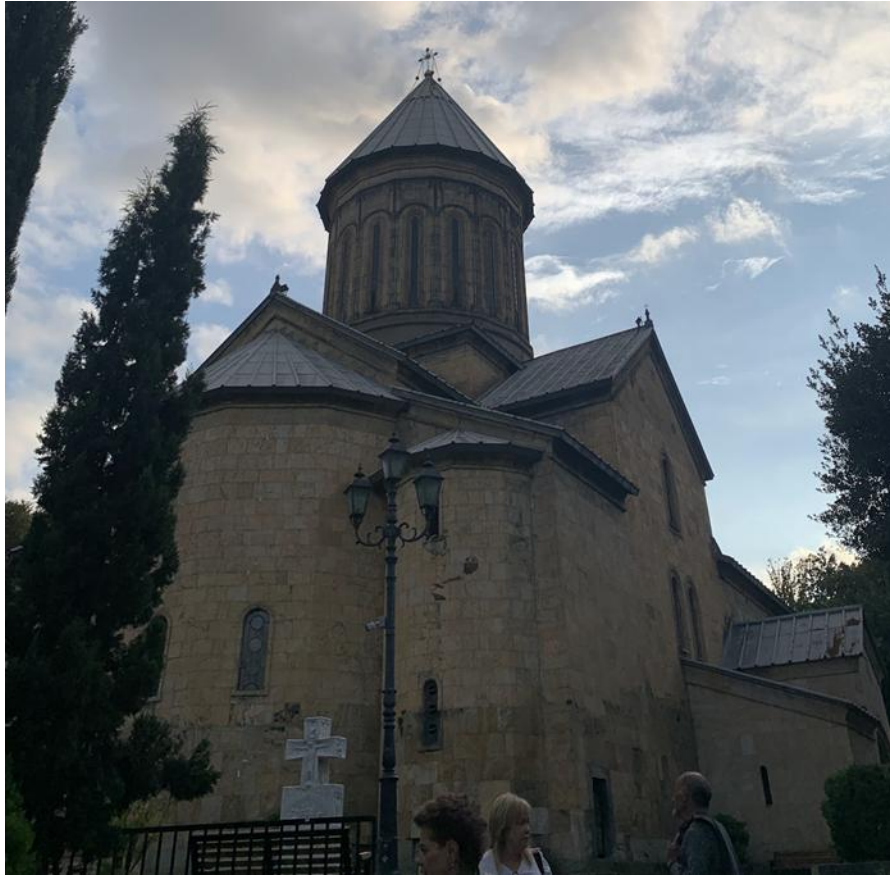
Sioni Cathedral (**Figure 2**), a cross-in-square/crossed-dome Georgian Orthodox church, construction of which was initiated by Vakhtang I Gorgasali, King of Iberia (Georgia) at the end of the V century and completed in the VI-VII centuries, was built under the patronage of Dachi of Iberia Ujarmeli, Guaram I Kourapalates and Adarnase I of Iberia. The Sioni Cathedral was damaged several times and rebuilt/repared, but the basic elements of the existing structure date from the XI-XII centuries. It is also located in Tbilisi on the right bank of the Mtkvari (Kura) river and constructed from dressed stone quarried in Algeti-Bolnisi and faced with yellowish sandstone-tuff slabs (Beridze, 2014; Beridze, 1954).

**Figure 2.** Sioni Cathedral - north-eastern façade  
Note. Photograph by N. Dzebisashvili, 2025.

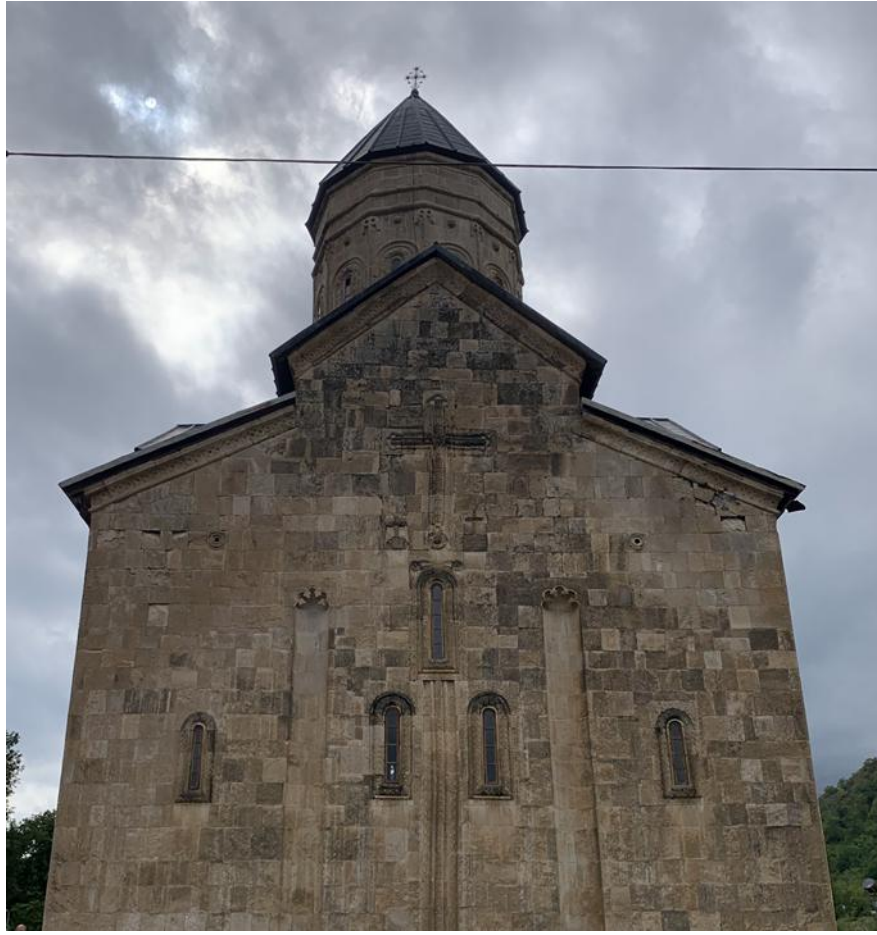
Barakoni Church (**Figure 3**), a prominent example of XVIII-century domed architecture, is located on the right bank of the Rioni River at the confluence with the Lukhuni River in the Racha region. It is a domed cruciform church and one of the last important monuments in the tradition of medieval Georgian architecture - adorned with rich ornamentation (Beridze, 2014). Built from locally sourced dolomite and calcite-based stone, it stands in close proximity to the large Shaori Reservoir constructed in the 1950s, potentially contributing to microclimatic changes affecting the monument (Beridze, 1974; Chokheli & Khelidze, 2022).

**Figure 3.** Barakoni Church - eastern facade.  
Note. Photograph by N. Dzebisashvili, 2025.

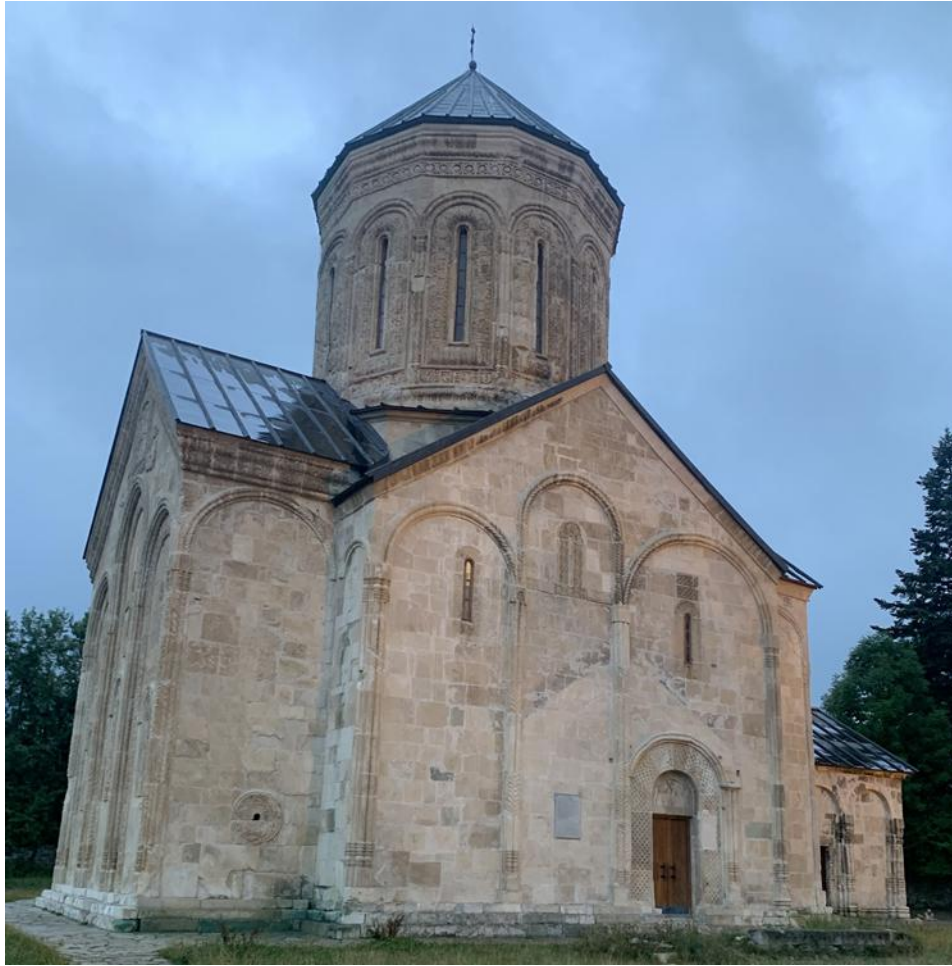
Nikortsminda Cathedral (**Figure 4**) is a masterpiece of national architecture. Constructed in the early 11th century by King Bagrat III of Georgia the Unifier, it is a Georgian cross-dome style church, with six-conches within a short-armed rectangular cross plan, which is located in the eponymous village in Racha. The decor of the exterior of Nikortsminda is an achievement of Georgian monumental plastic art. Nikortsminda has one of the richest and most beautiful decorations/stone carvings of all Georgian churches and cathedrals, with a fusion of several different styles. The monument has not undergone major changes during its existence, and the dome of the temple has remained in its original form. Its construction material primarily consists of sandstone containing calcite, quartz, and clinoptilolite, a zeolite phase known for high water retention and capillarity (Beridze, 2014). As the Nikortsminda Cathedral is located approximately 4 km north of the Shaori Reservoir, the influence of microclimatic changes on the monument is even more likely than in the case of Barakoni (Beridze, 1974; Chokheli & Khelidze, 2022). Since 2007, the cathedral has been on the Tentative List for status as a UNESCO World Heritage Site (UNESCO, 2025); however, its assignment to World Heritage status was postponed, both due to the lack of a comprehensive management and conservation plan for the monument and to the lack of scientific documentation of the material condition and environmental impact.

Figure 4. Nikortsminda Cathedral - southern facade (N. Dzebisashvili, 2025)
