Energy Rehabilitation of Social Housing in Vulnerable Areas

Case study: a 1950s Building in a Medium-sized Mediterranean City

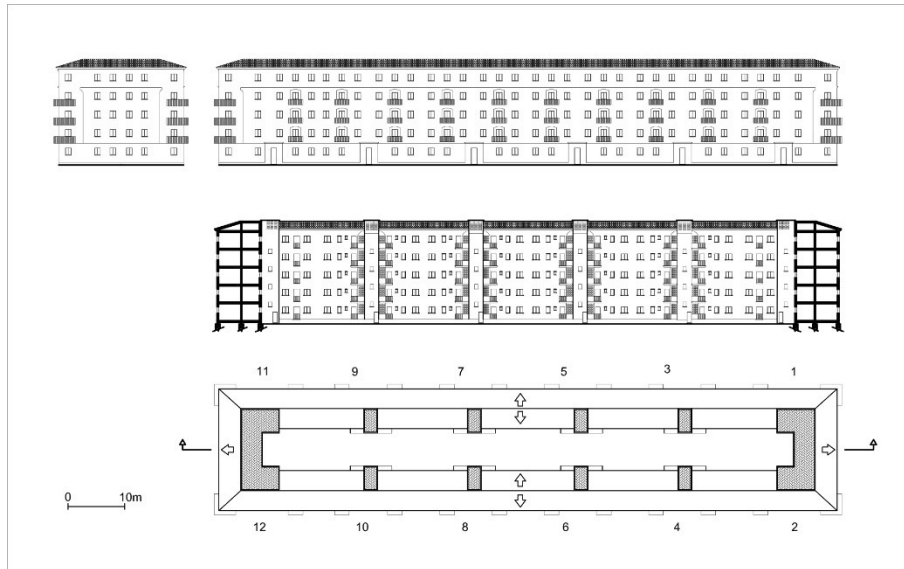
Figure 4. Front side view, side elevation, section and roof plans

Figure 4 shows the front side view and the side elevation plan, section and roof plan. Figure 5 represents a 3D image of the block using the Revit software, drawn after the visits made to the site.

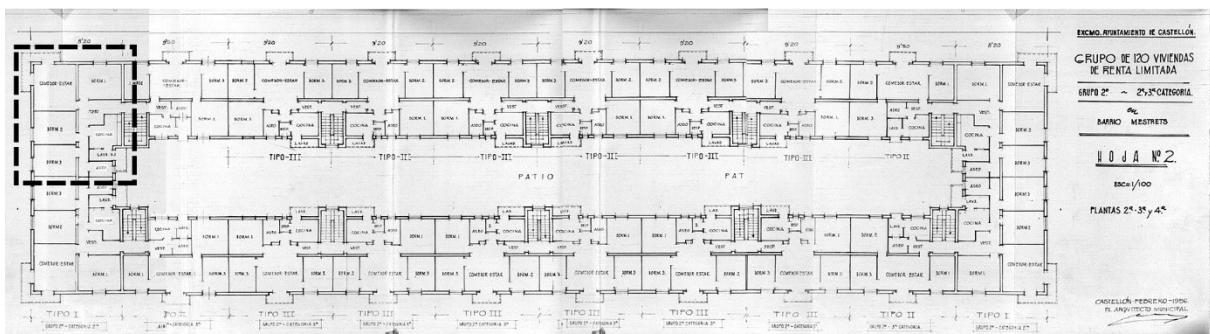
Figure 6. Second Floor (Original plans)

There are four buildings in the corners of the block, while the rest are terraced buildings which present better energy performance as they are less exposed to the outer environment. The building located in the north-west corner (357° north) is the worst in energy performance terms. In order to simplify simulation, only this building was simulated. There are three types of housing, as seen in the original plans presented in Figure 6, where the selected building is indicated. Figure 7 shows the floor plan, with dwellings types I and II, included in the building selected in the block. Dwelling type III is included in the terraced buildings in the block.

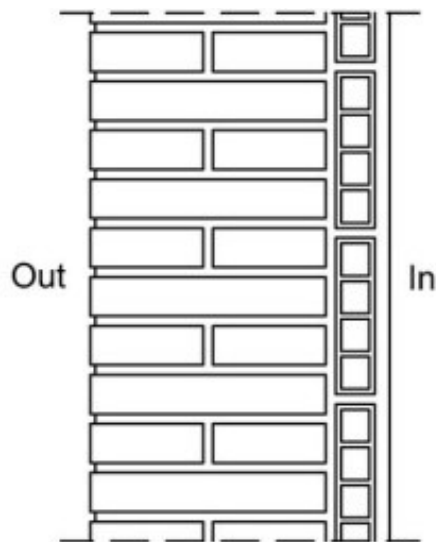
Figure 8.

Thermal envelope	Constructive solution	Transmittance U ($\text{W}/\text{m}^2\text{K}$)	Figure
Façade 1	Bearing wall formed by double leaf brick: exterior masonry wall of ceramic solid brick of 1 foot-thick with cement mortar joints + inner skin of hollow ceramic brick, 4-cm thick, with cement mortar joints + plastering. Exposed area: N 93.41 m^2 ; W 78.93 m^2	1.44	Figure 8

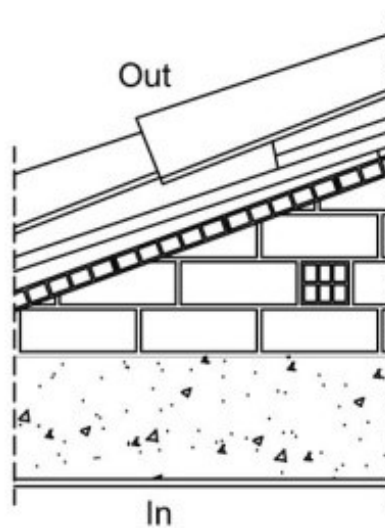
Figure 11.

Façade 2	Bearing wall formed by double leaf brick: continuous outer coating with cement mortar + exterior masonry wall of ceramic solid brick of 1 foot-thick with cement mortar joints + inner skin of hollow ceramic brick 4 cm-thick with cement mortar joints + plastering. Exposed area: N 190.64 m ² ; W 100.63 m ² ; E 57.84 m ² ; S 169.51 m ²	1.29	Figure 8
Windows	Wood carpentry with single glazing.	Carpentry: 2.20 Glazing: 5.50	Figure 9
Roof 1	Flat roof ventilated, trafficable: Finishing ceramic tiles + mortar layer 5 cm + bituminous sheet + ventilated air chamber + reinforced concrete one-way slab 30 cm, ceramic hollow plot + plastering. Exposed area: 38.83 m ² .	1.37	Figure 10
Roof 2	Gable sloping roof ventilated 16°: finishing ceramic gables + mortar layer + ceramic tiles for roof slope + ventilated air chamber + reinforced concrete one-way slab 30 cm, ceramic hollow plot + plastering. Exposed area: 116.03 m ² .	1.05	Figure 11

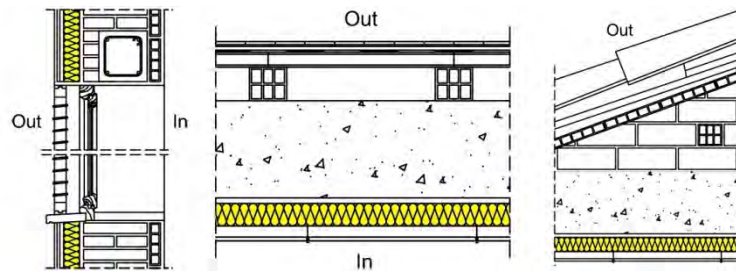
Figure 13. Façade, sloping roof and flat roof refurbishment solutions

Table 3 shows some constructive solutions (Huedo, Mulet & López-Mesa, 2016), along with their advantages, disadvantages and features by bearing in mind the technical, environmental, economic and heritage perspectives. The selected solutions are shaded in grey in Table 3 and represented in Figure 13. For façades, inner insulation (FI) was ruled out because of the dimensions of rooms. It would mean reducing the areas of rooms as they could not fulfil the minimum required dimensions according to new standards. Therefore, the outer solution with the External Insulation System was adopted in this case because it was more convenient than the ventilated façade,

and fell in line with different criteria. The convenience of this solution is supported by other studies (Sierra-Pérez, Boschmonart-Rives & Gabarrell, 2016) and can be applied to both façade types.

For roofs, the inner solution proved more convenience when looking at advantages and disadvantages. The same solution involving mineral wool and finishing plaster board could be applied to roof 1 (SRI) and roof 2 (FRI).

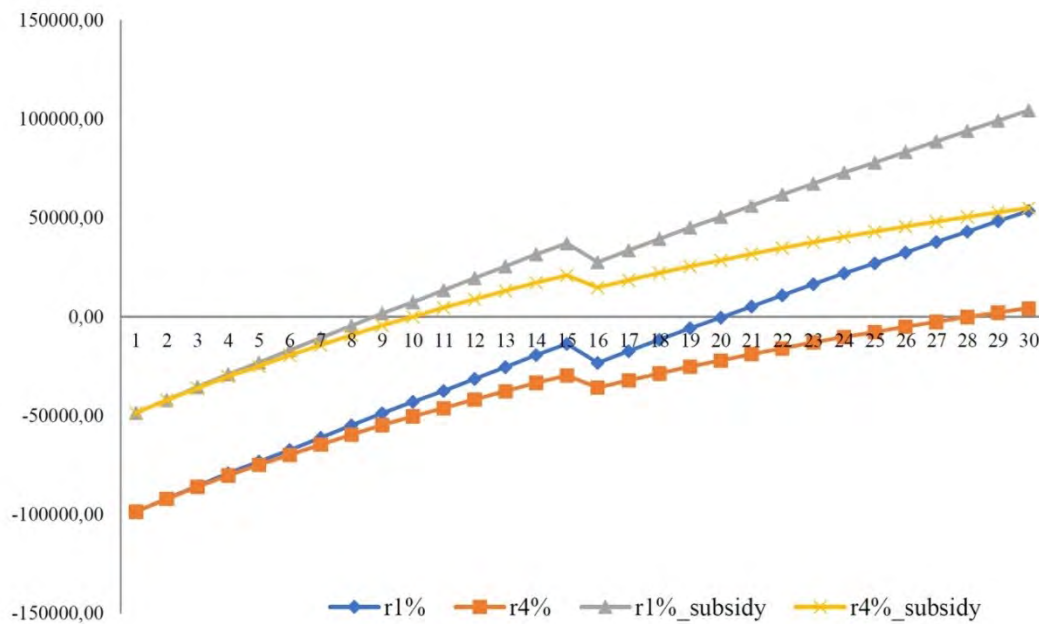
Figure 14. Façade, sloping roof and flat roof refurbishment solutions

The graphic represented in Figure 8 shows the accumulated NPV for two discount rates, 1% and 4%. NPV is €53,184.12 for 1% and is €4,736.1 for 4%. With the starting hypothesis of Table 5, we can see that the investment starts to be positive from year 20 and 28 for the 1% and the 4% discount rate, respectively. This is not a surprising result if we consider the private costs and only the carbon price a social cost.

Some subsidies can be considered in the calculations, if we bear in mind that the building is included in an ARRÚ, as mentioned in Section 3.1. This would result in a more optimistic scenario with a shorter payback, as calculated in previous studies (Alguacil et al., 2017). For example, estimating a hypothetical subsidy of €5,000.00/dwelling, the investment would be returned in less time, as seen in Figure 14.
